**TOWN CLERK/FRONT OFFICE REPORT
OCTOBER 2016**

2017 Historic Property Grant Application

Bostwick House		
Historic and/or current name of the property (if applicable)		
3901 48th Street, Bladensburg, MD 20710		
Street Address	City	ZIP

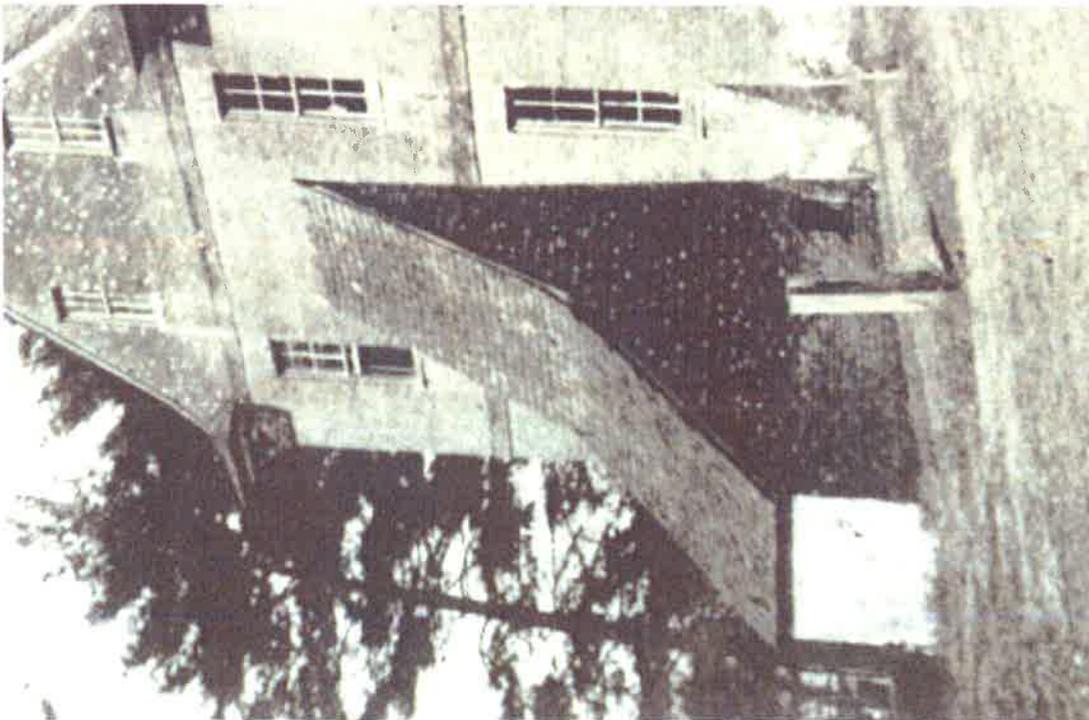
Figure 1. Buttress ca. 1890, prior to Colonial Revival changes to Bostwick House and property. Note wooden shingle roof on buttress and glazed header brick on east wall.

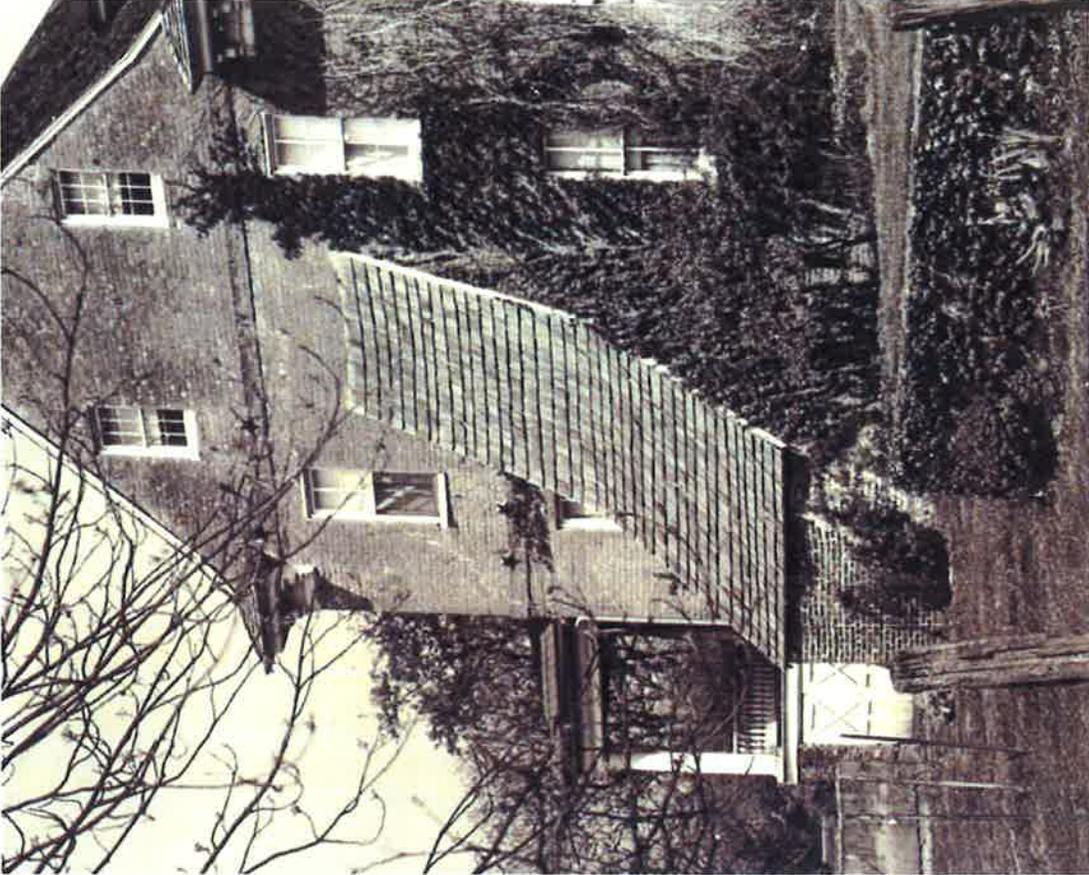
Figure 2. Buttress in 1936 HABS photo. Prior to painting of the entire structure. Note apparent brick damage to southeast corner and dense ivy on east wall.

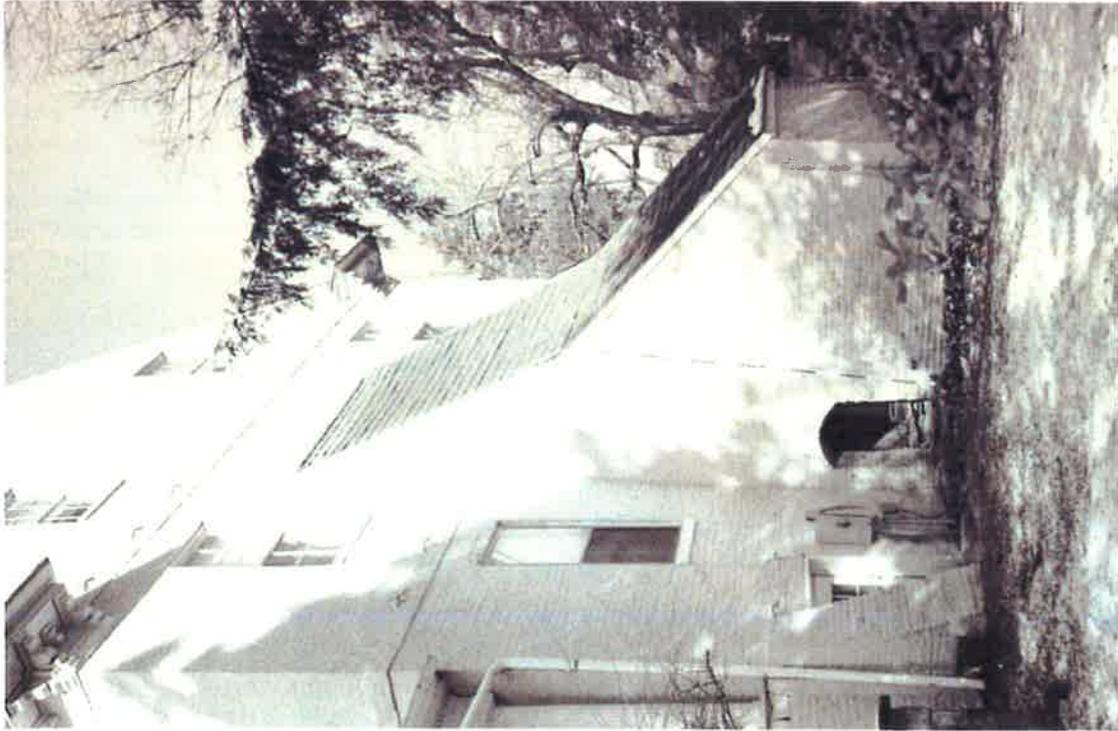
Figure 3. Buttress in 1989 HABS photo. Roof has been resingled with cement/asbestos shingles.

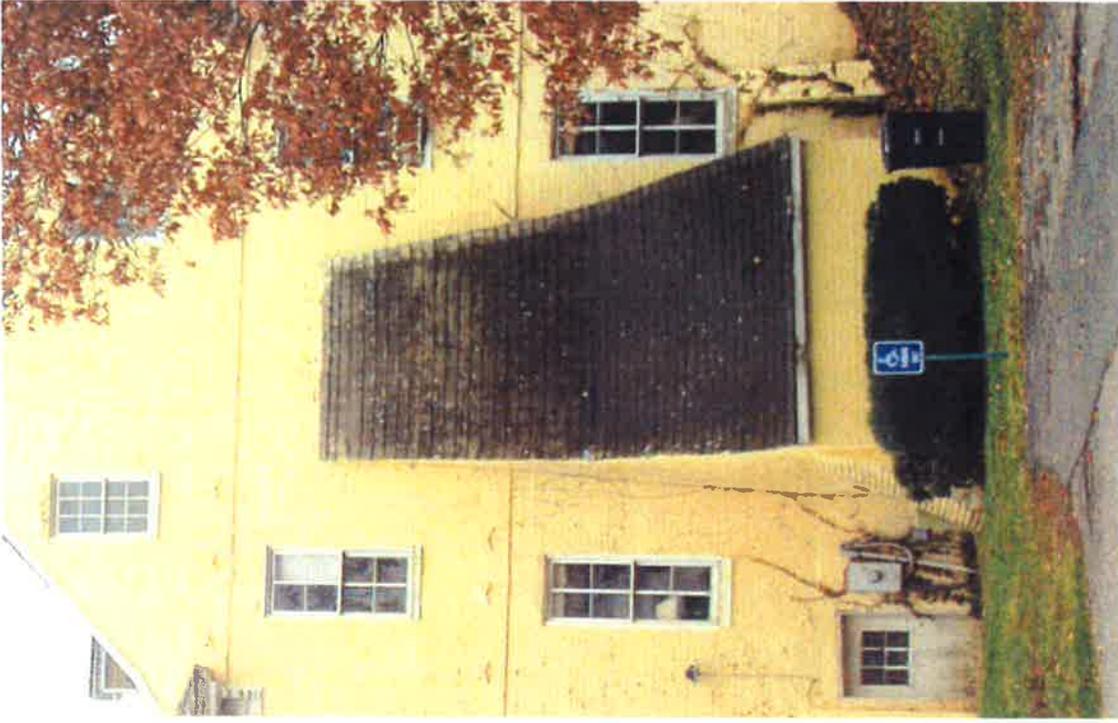
Figure 4. Buttress in 2007. Generally stable condition overall.

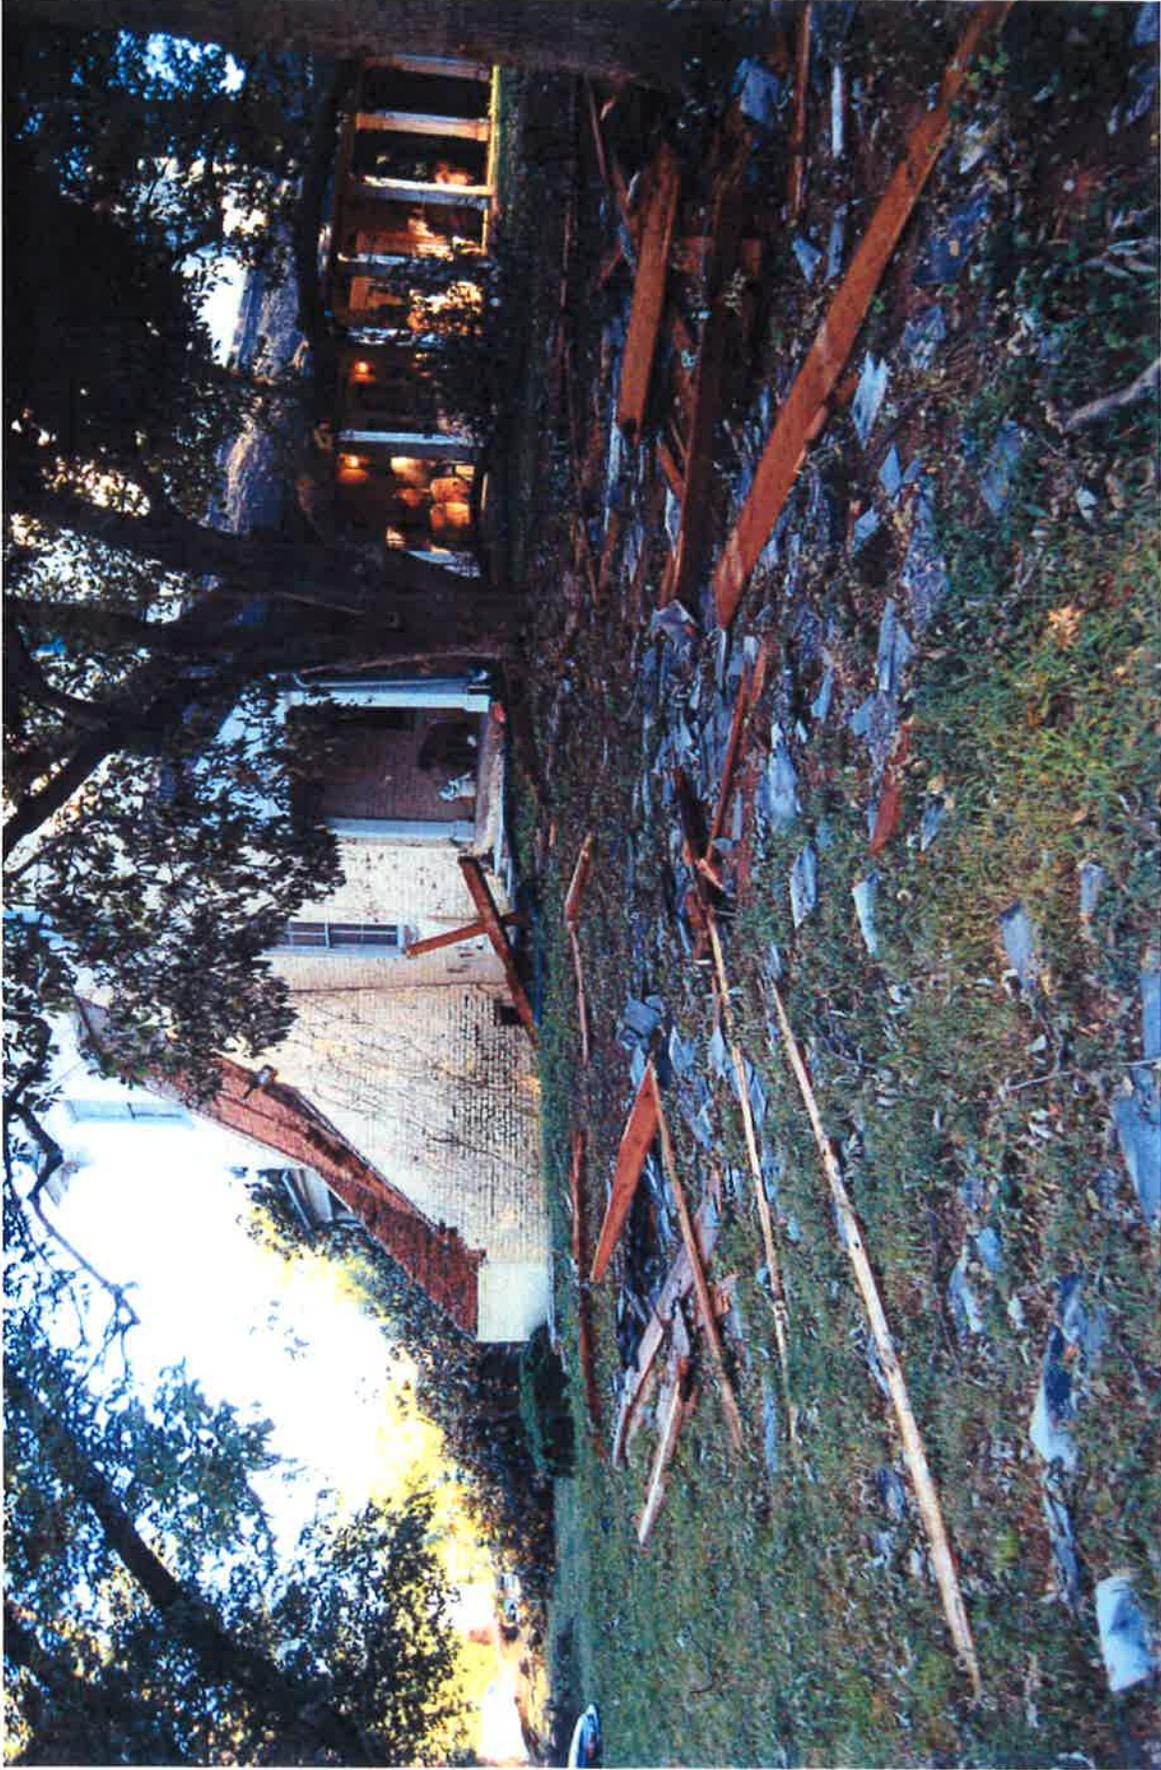
Figure 5. Aftermath of the violent microburst that torn off the buttress roof in June 2012. Roof decking of circular sawn lumber (with wire nails) and cement/asbestos shingles cover the back yard.

In June 2012, the roof of the buttress was totally destroyed during a microburst weather event (estimated at between 80-100 mph). This powerful wind lifted the entire roof structure off the buttress and carried it out into the rear yard where it struck a tree and disintegrated. Repairs were delayed due to more critical safety needs to repair the roof, also damaged in the microburst, and the two end chimneys severely damaged in the previous year's earthquake. With the interior of the buttress now fully exposed to the weather, the structure is in dire need of repair.

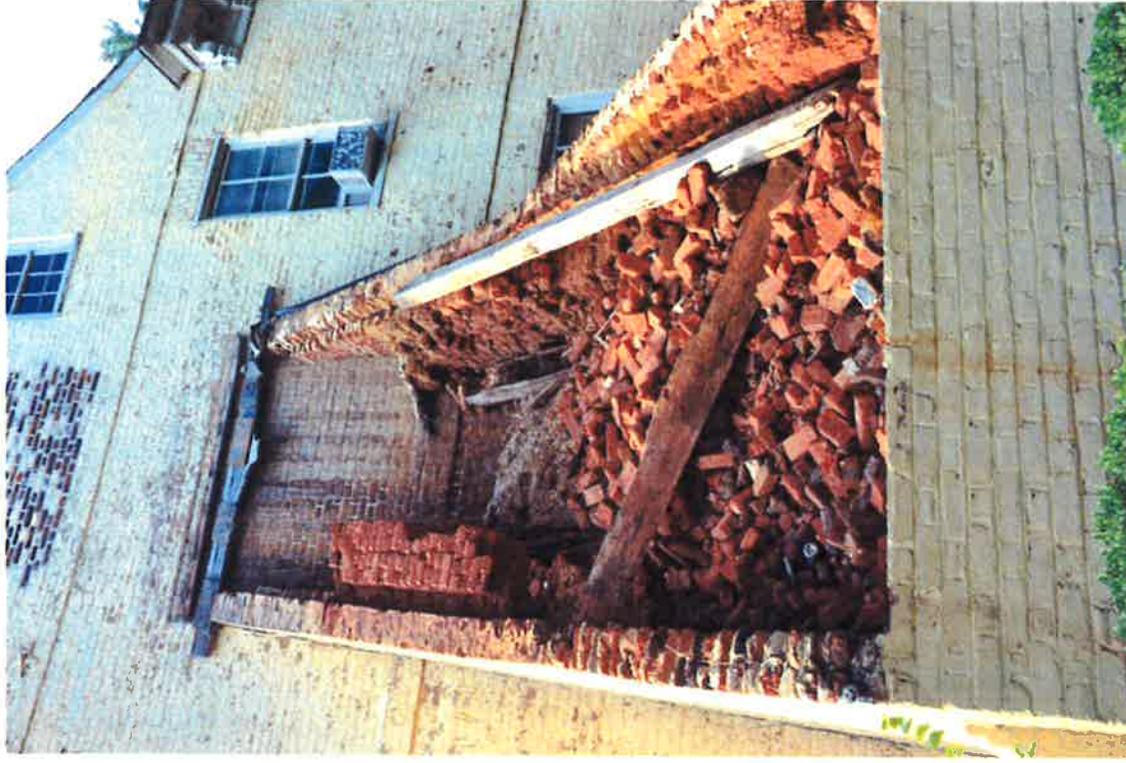
Figure 7. Buttress interior in 2014. Much of the soft unmortared interior brick work has collapsed.

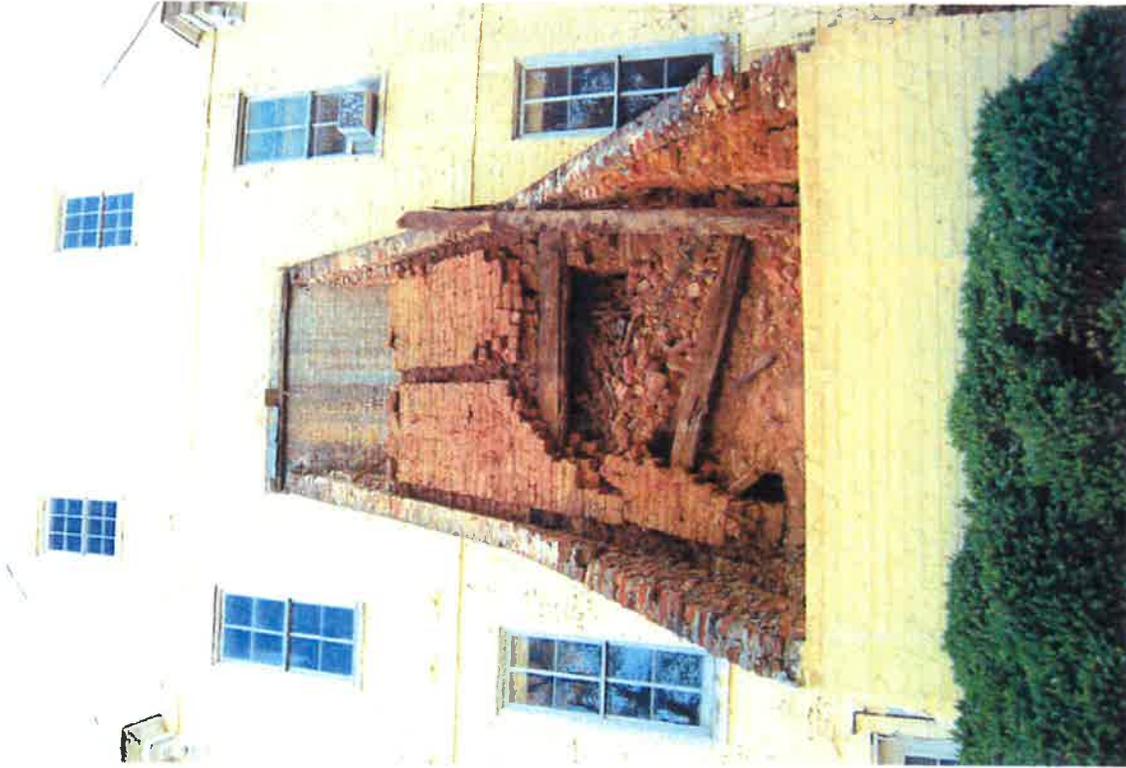
Figure 6. Buttress interior shortly after roof destroyed in 2012. Interior soft brick is unmortared and supported on timber "ledges."

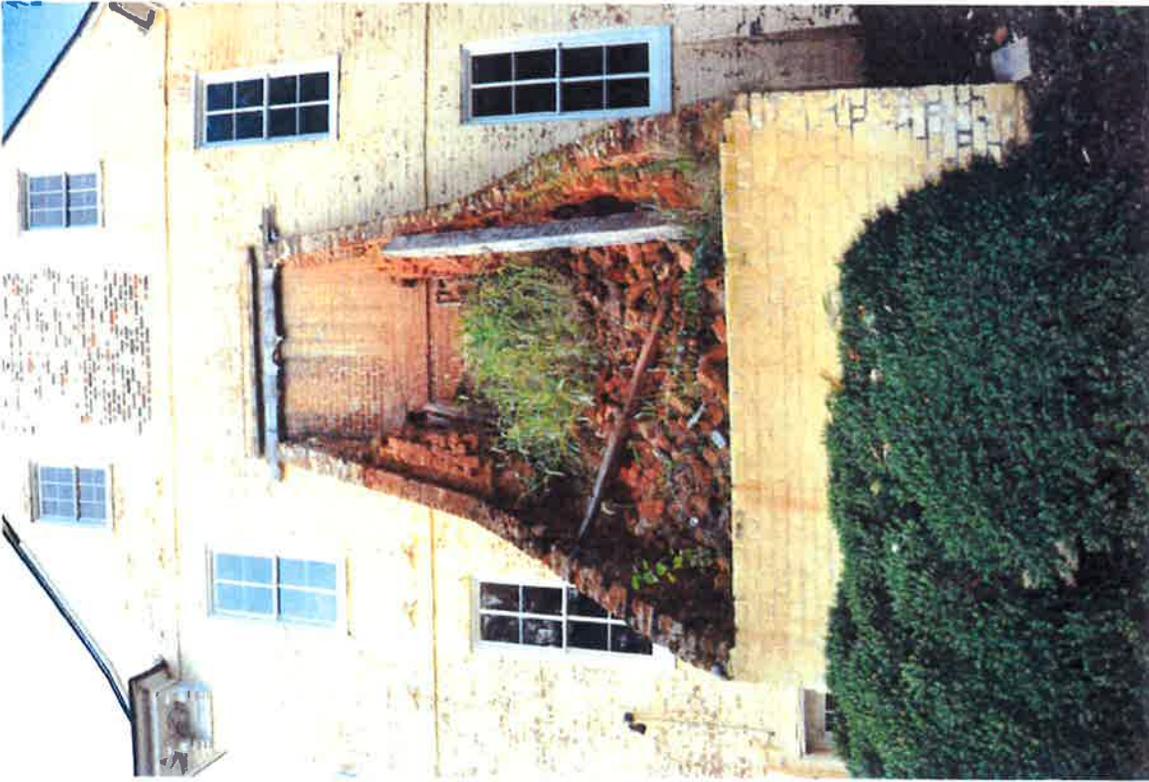
Figure 8. Butters interior in 2016, showing continuing deterioration.

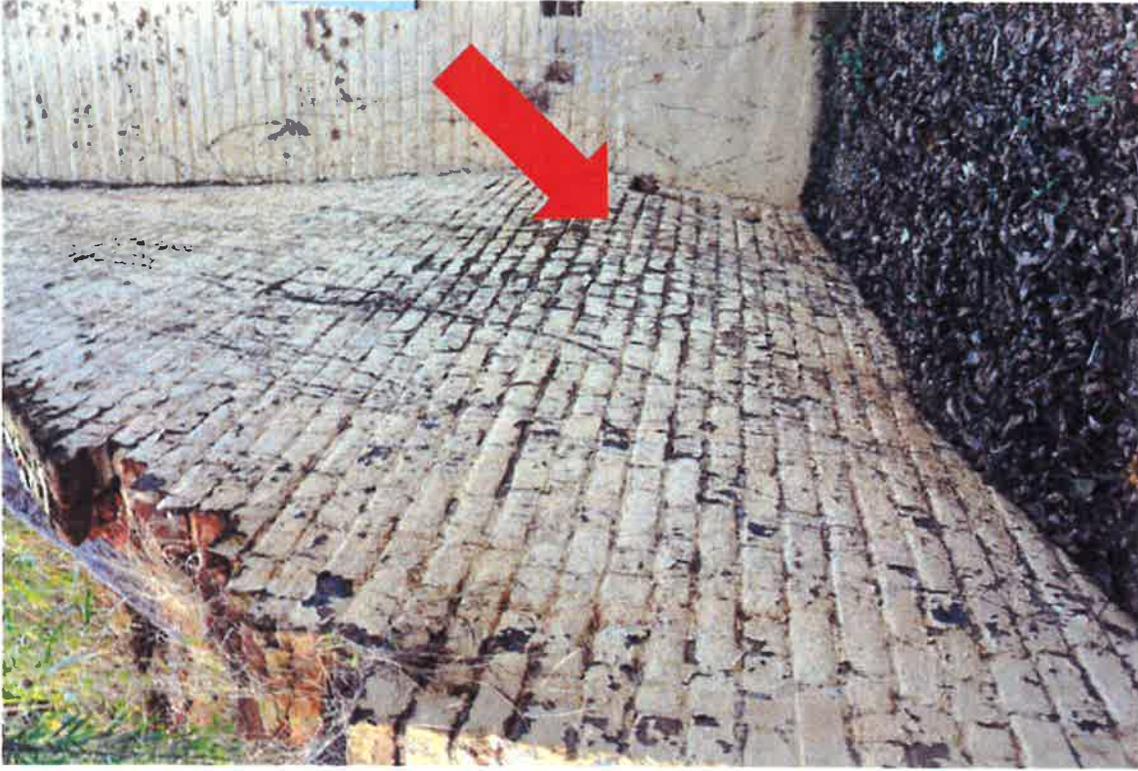
Figure 9. East wall of butters. Arrow points to large deflection (bulge) in wall (+/- 12 inches) about 2 feet above the ground surface.

In addition, the east side of the buttress is severely bowed and in danger of collapse as it is not tied to the rest of the buttress structure; this east wall will need to be deconstructed and rebuilt. It is critical that a documentation and restoration project be carried out avoid further damage to the structure, further loss of information regarding this unique structure, and possible damage to the south wall of the main house should the east wall of the buttress collapse.

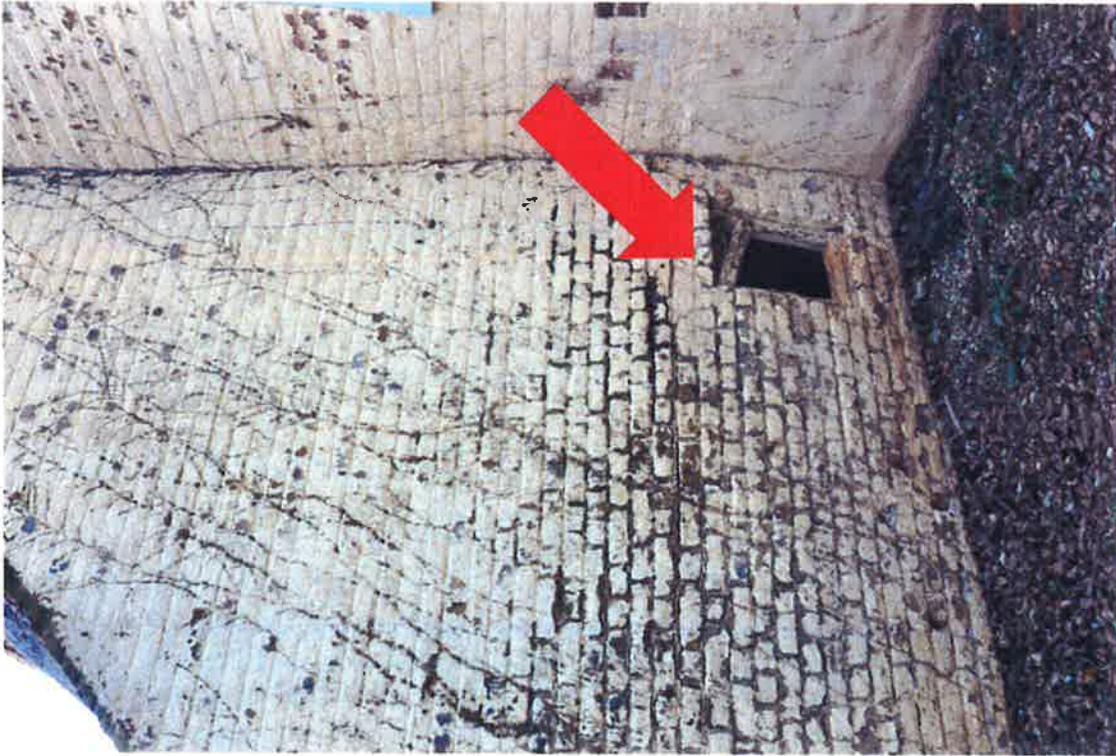
Figure 10. East wall of buttress. Arrow points to deflection and failing brick above the window opening.

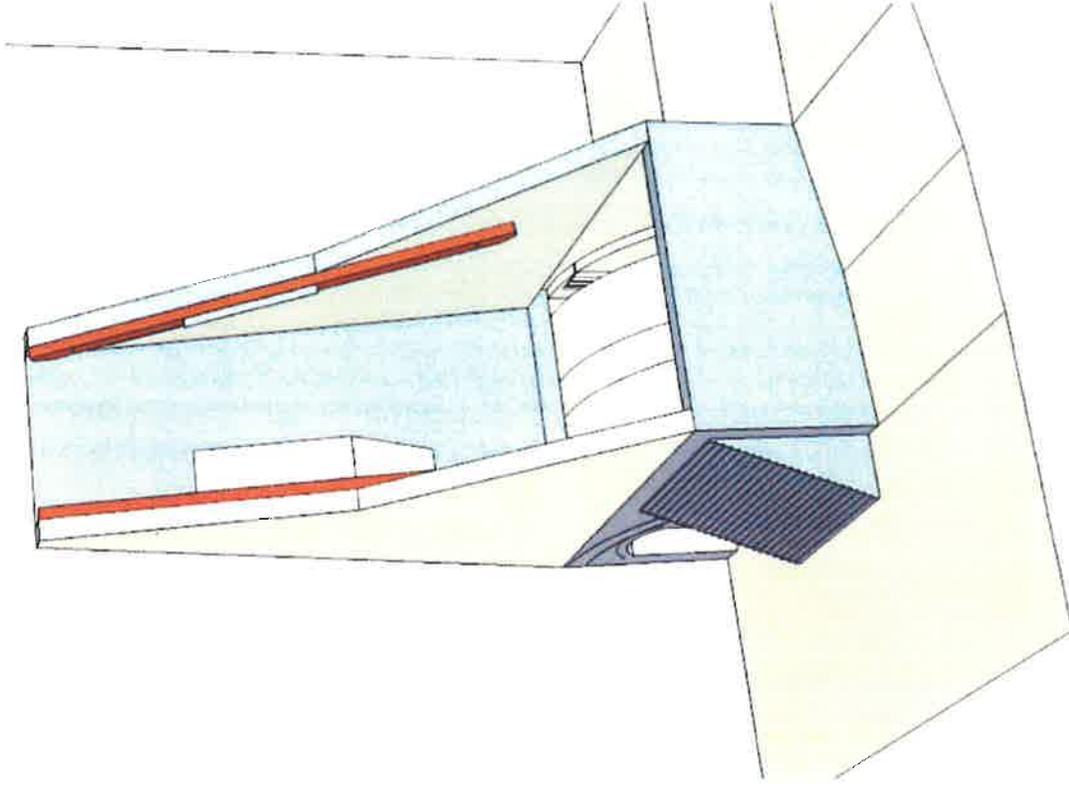
Figure 11. Preliminary Sketchup model of buttress based on data that could be derived from direct measurement and photographs (Stephen Neuhouser, delineator)

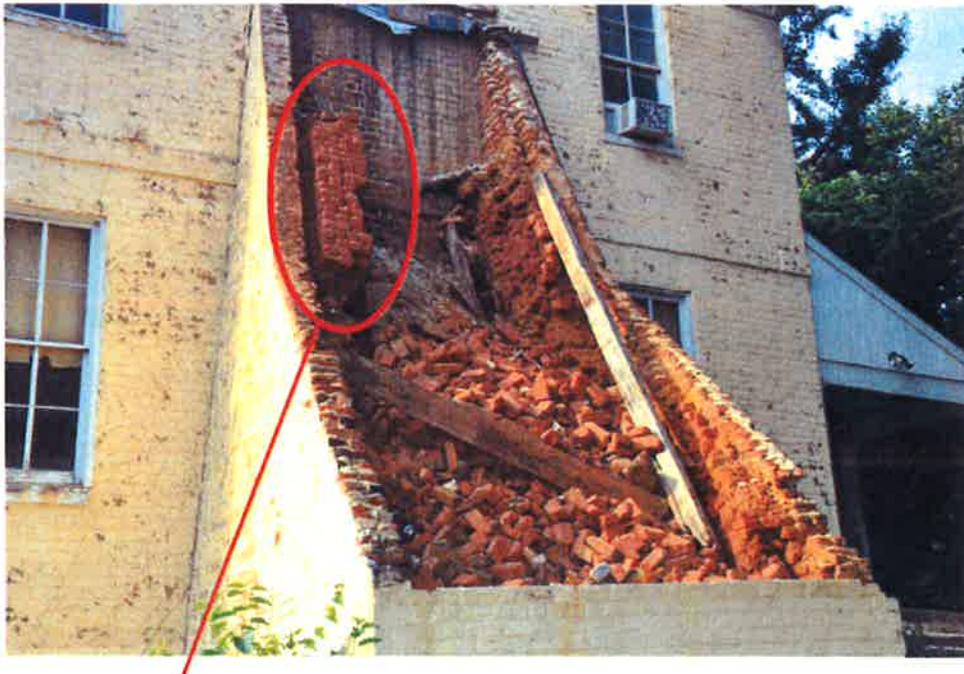
This section will be removed first as it is unstable and could collapse.

- 4) Photograph and remove remaining interior bricks near top of structure (currently a falling brick hazard – see attached photo);
- 5) Excavate and remove interior brick rubble and wooden timbers;
